FIG Working Week 2007, Hong Kong

Monitoring Slope Failure at Kadoorie Agricultural Research Centre with a 3D Laser Scanner

This paper focuses on the use of 3D laser scanner in capturing the formation of cracks and surface movement during the failure

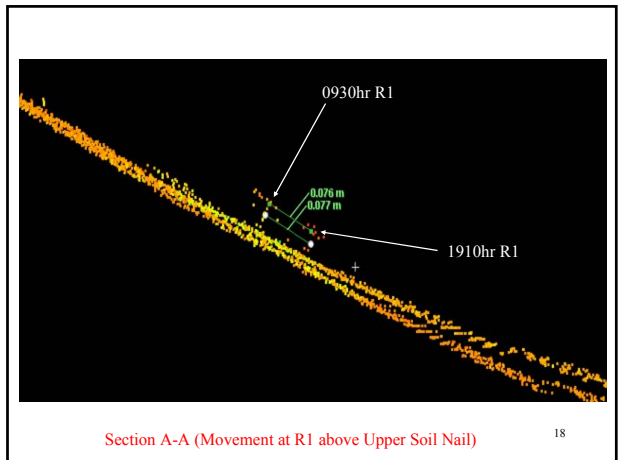
Section A-A (Movement at R1 above Upper Soil Nail)

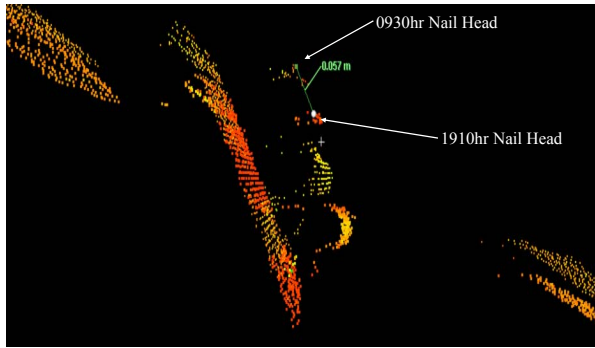
Section A-A (Movement at Upper Soil Nail Head)

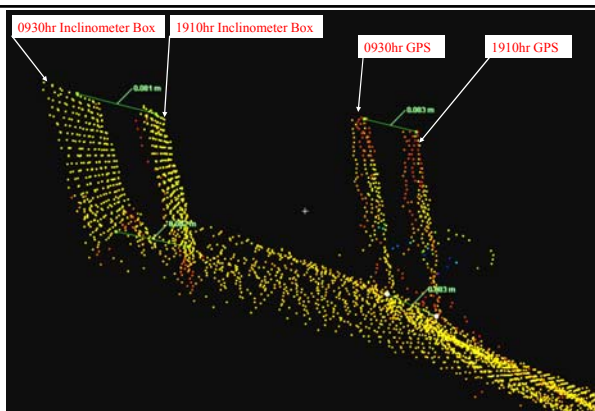
Movement at Crest Near Top Inclinator Position (Close-up View of Section C-C)

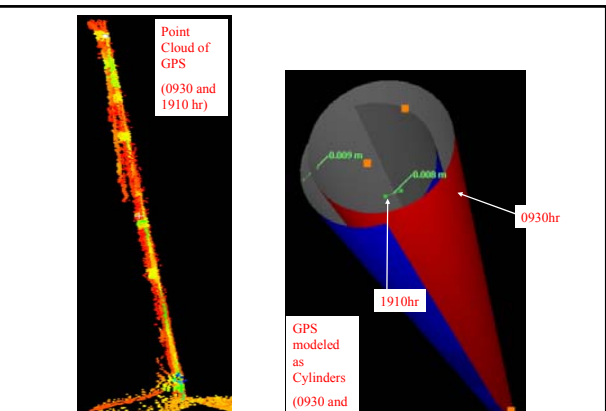
Close-up View of GPS (centerline movement 8mm)

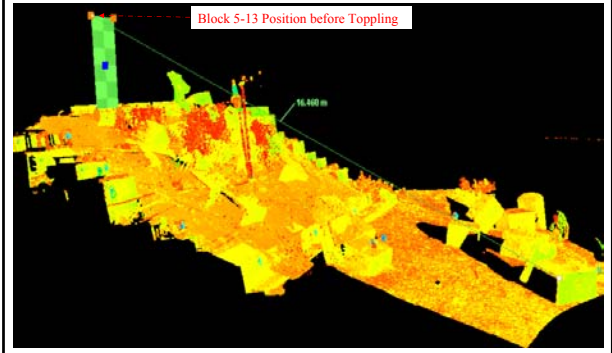
Travel Distance of Block 5-13

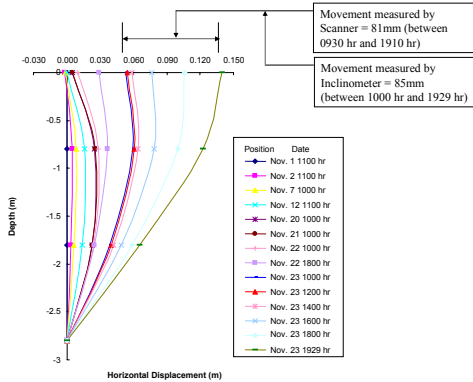
**Inclinometer at Crest of Slope
(Horizontal Displacement against Time)**

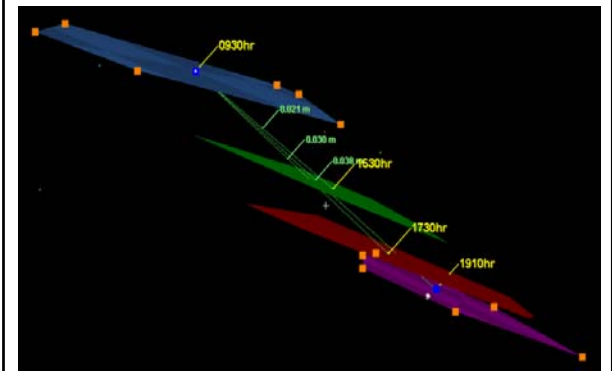
**Movement of Reference Point R6 against Time
(0930hr, 1530 hr, 1730 hr and 1910 hr)**
