Innovation from Disaster!!

Maurice PERWICK, New Zealand

Following the major earthquakes of September 2010 (7.1M) and February, June and December 2011 (6.0M to 6.3M), we carried out hydrographic and terrestrial surveys at the local Port 'Lyttelton - Port of Christchurch' to assist Geologists and Engineers to determine displacement of structures and elevation changes to the seabed and Tide Gauges.

FIG Working Week 2016
Recovery from Disaster
Christchurch, New Zealand, May 2-6, 2016

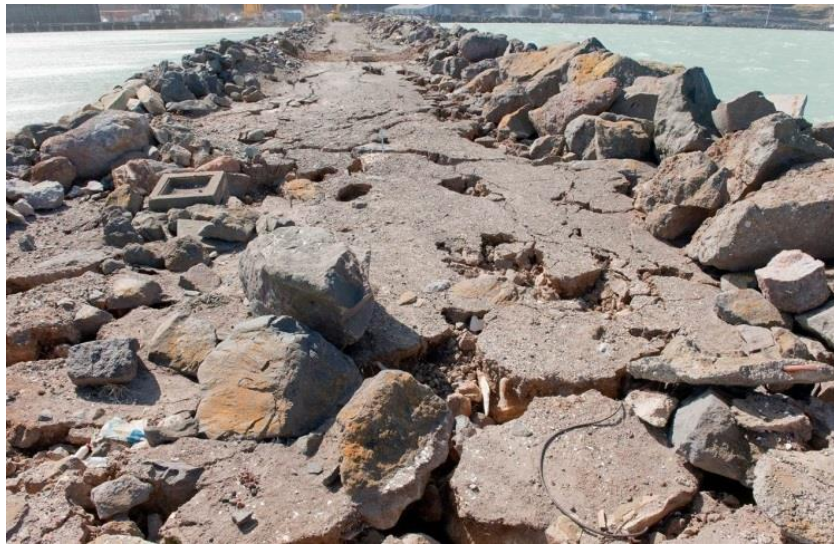
Fingers and breakwaters suffered greatly as they were surrounded by water and although heavily armoured with rock, collapsed into the harbour muds. These were temporarily abandoned until other more important issues had been attended to.

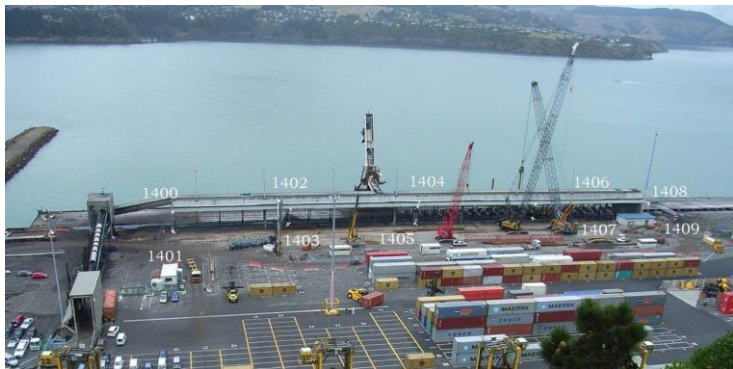
We set up a number of small prisms on the wharf and coal galley structure as well as on the land behind the wharf and further back as a reference line. The points were monitored for movement every 15-20 minutes for nearly one year using a Trimble monitoring application on the TSC3 Controller. We used a Trimble S8 Total Station with long range fine auto lock for robotic tracking of these points. The application reported the displacement and set off alarms where thresholds were exceeded. The piling operation caused the toe of the embankment under the wharf to fail with a resultant shift of the wharf and building structure.

Work was stopped and the piling continued but with the two cranes separated well apart.

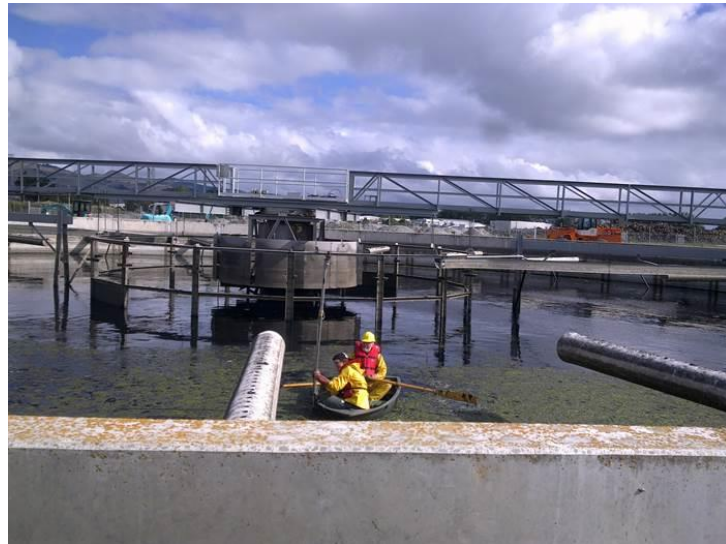
The clarifiers were large concrete tanks with mechanical stirring and oxygen arms.

The violent uplift caused by the earthquake fractured these tanks and our task was to determine the extent of damage.

The clarifier survey was essentially a topographical survey from a small boat floating in the morass. The profiles and contour plots for each survey showed the extent of siltation in the ponds and fractures of the clarifier base.

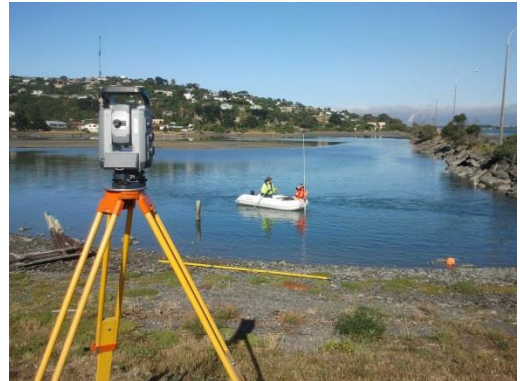
The uplifting of the bridge culverts draining McCormacks Bay needed to be addressed to ensure that drainage of the bay continued. The rising main (sanitary sewerage) from the Mount Pleasant area was fractured and some product was pumped directly into the bay and required flushing.

We carried out detailed topographical surveys using GPS-RTK, Total Station and Hydrographic Echo Sounder surveys to produce 3D models of the causeway and Redcliffs seawalls. The seawalls are currently being reinstated this year.
